Flood Control Project Maintenance**2012 Structure Summary Report****Overall Unit and Item Ratings****DWR Sutter Maintenance Yard****Butte Slough Drainage Structure**

Flood Control Project Maintenance
2012 Structure Summary Report
Overall Unit and Item Ratings

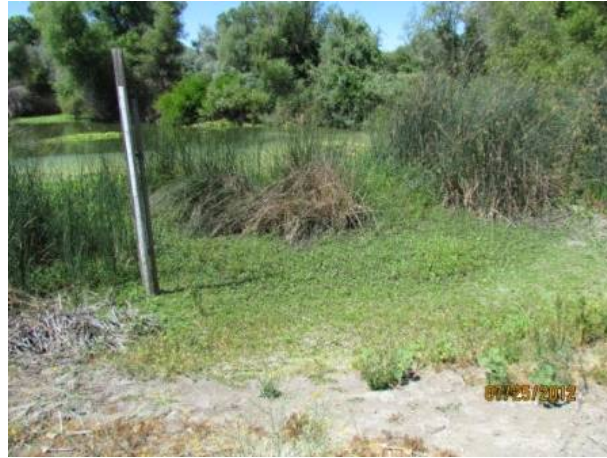
Levee Mile Report Line	18
Start Levee Mile	0.00
End Levee Mile	0.00
Location	
Category	Pump Stations
Item	Flap Gates
Vegetation growth was obstructing the view of flap gate opening.	
pkazi_t_20120810_187.jpg

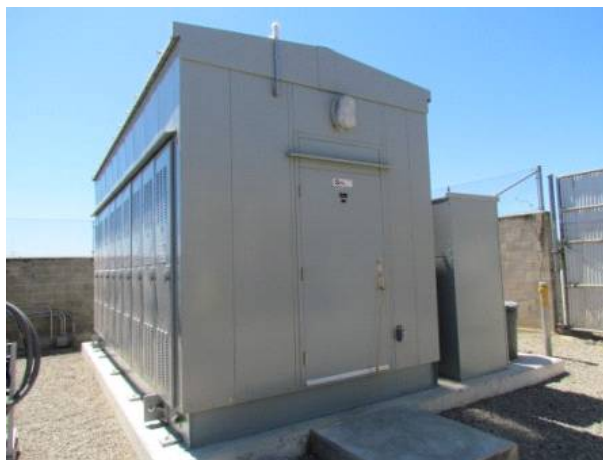
Levee Mile Report Line	3
Start Levee Mile	0.00
End Levee Mile	0.00
Location	
Category	Pump Stations
Item	Plant Building
07/20/2012 View of plant building under construction.	
mkhashch_t_20120723_493.JPG

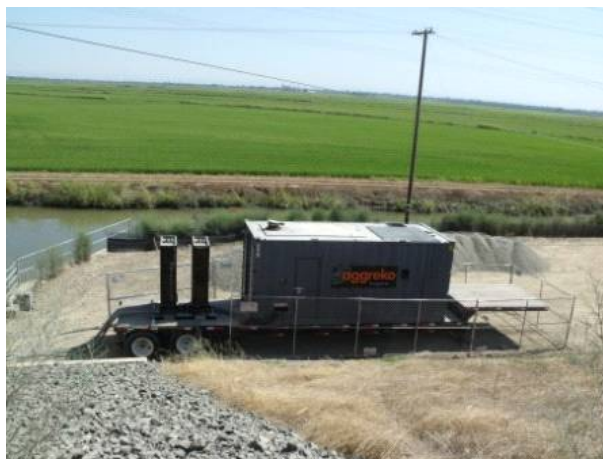
Levee Mile Report Line	8
Start Levee Mile	0.00
End Levee Mile	0.00
Location	
Category	Pump Stations
Item	Power
08/24/2011 Photo shows emergency generator that is being kept on site to operate the pumps, if necessary during reconstruction.	
mkhashch_t_20120709_020.jpg

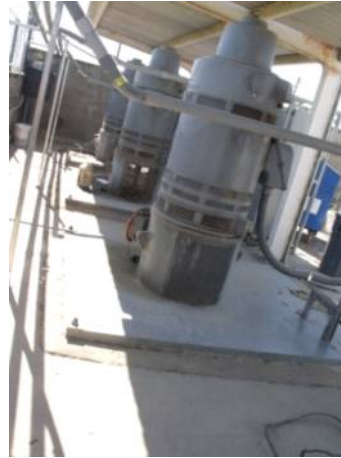
Levee Mile Report Line	9
Start Levee Mile	0.00
End Levee Mile	0.00
Location	
Category	Pump Stations
Item	Motors, Engines, Fans & Gear Reducers
08/24/2011 Photo shows pump motors, which appear to be in operating condition.	
mkhashch_t_20120709_021.jpg

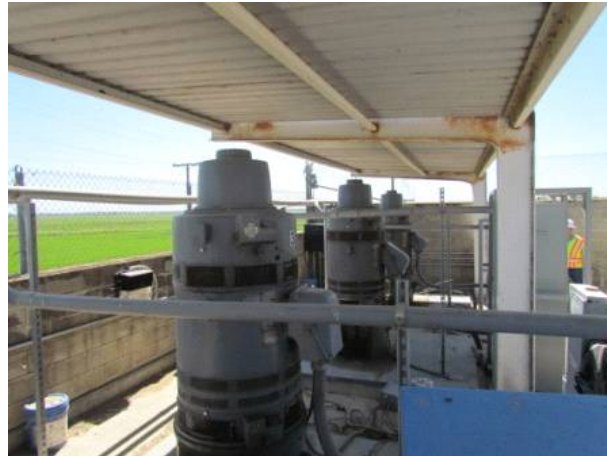
Levee Mile Report Line	9
Start Levee Mile	0.00
End Levee Mile	0.00
Location	
Category	Pump Stations
Item	Motors, Engines, Fans & Gear Reducers
07/20/2012 Photo shows pump motors, which appear to be in operating condition.	
mkhashch_t_20120723_487.JPG

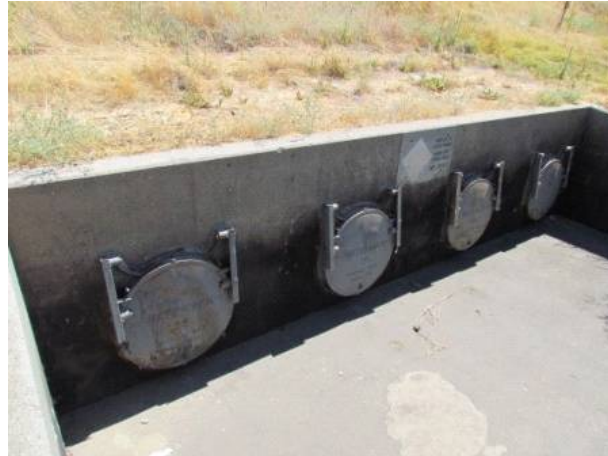
Levee Mile Report Line	18
Start Levee Mile	0.00
End Levee Mile	0.00
Location	
Category	Pump Stations
Item	Flap Gates
07/20/2012 Photo shows flap gates and concrete outfall structure.	
mkhashch_t_20120723_490.JPG

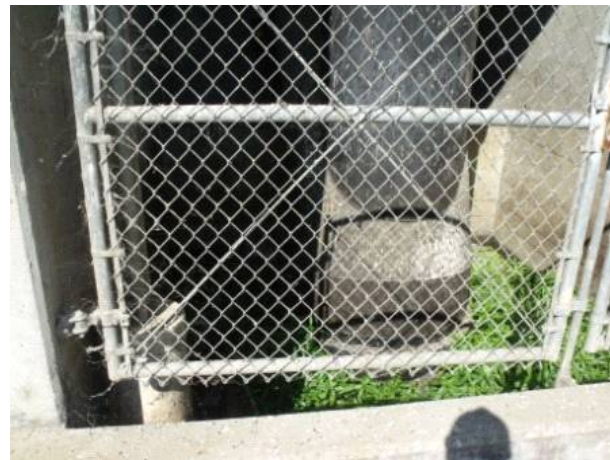
Levee Mile Report Line	11
Start Levee Mile	0.00
End Levee Mile	0.00
Location	
Category	Pump Stations
Item	Sumps/Wet Well
08/24/2011 Photo shows one sump with vegetation present.	
mkhashch_t_20120709_031.jpg

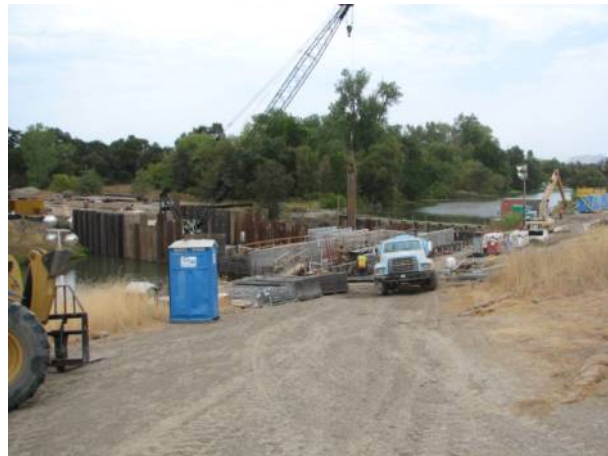
This is a view of the downstream work for the replacement weir.
